NASA TN D-1880

EFFECT OF TWO BRAZE COATINGS,
PROCESSING VARIABLES, AND HEAT
TREATMENTS ON 1200° F STRESS-
RUPTURE STRENGTH OF L-605,
A-286, AND INCONEL 700 SHEET

by John H. Sinclair and Charles A. Gyorgak

*Lewis Research Center
Cleveland, Ohio*

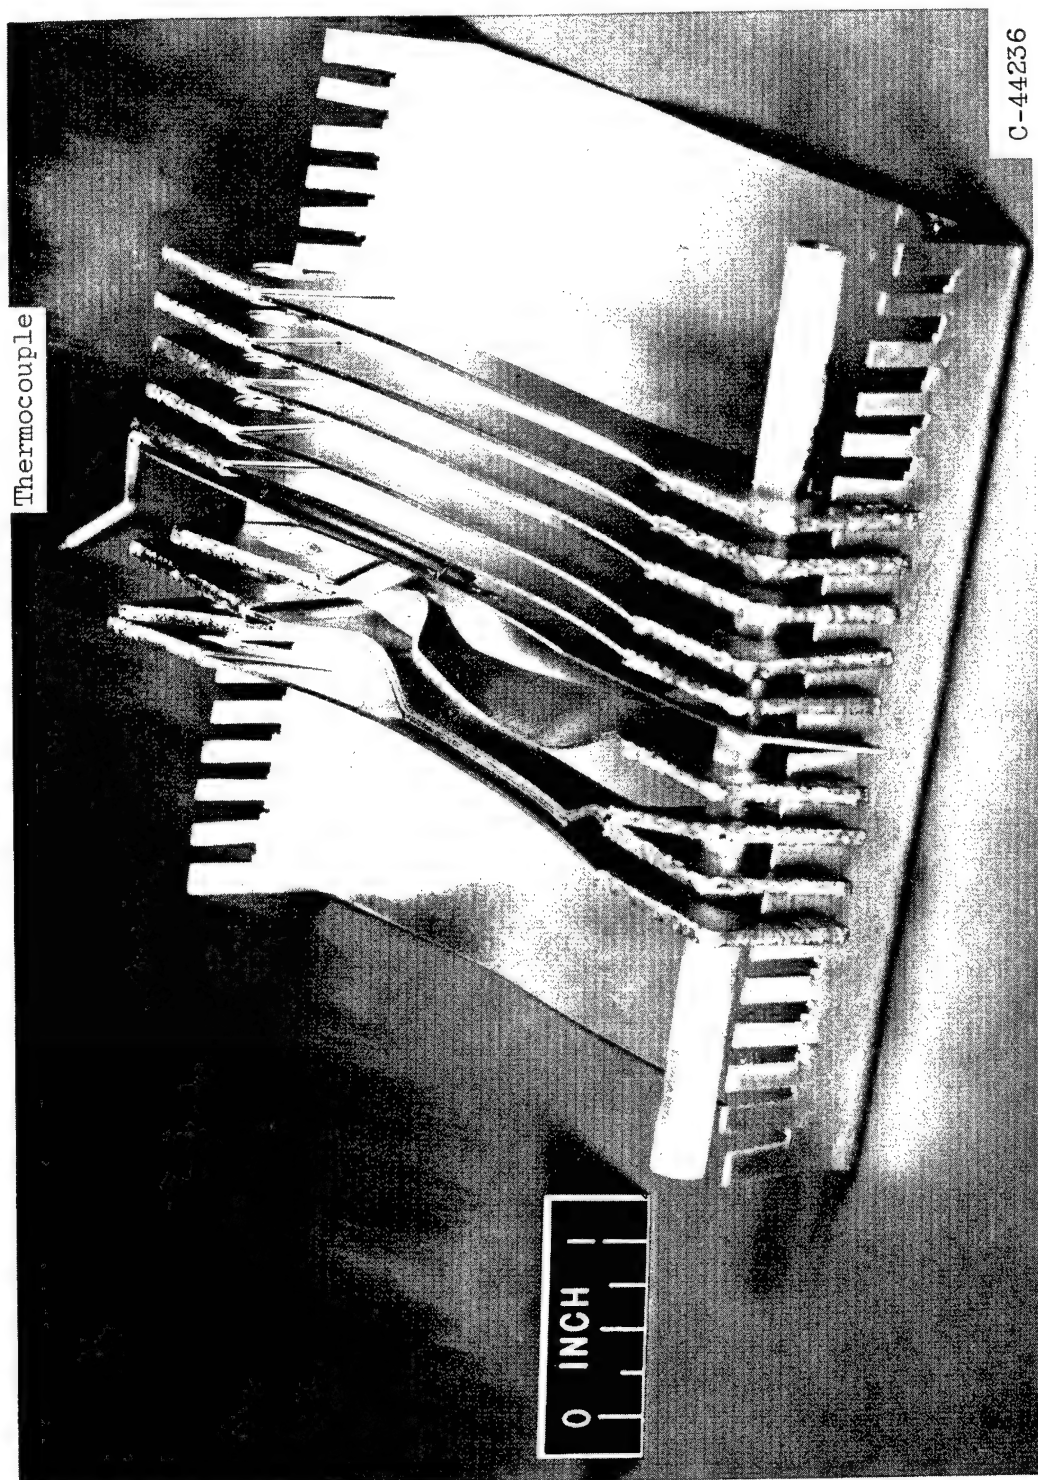
Figure 6. - Sagging of Inconel 700 stress-rupture specimens heat treated at 2275° F following application of NiCrSiB. (Specimens to right of thermocouple are not braze coated.)

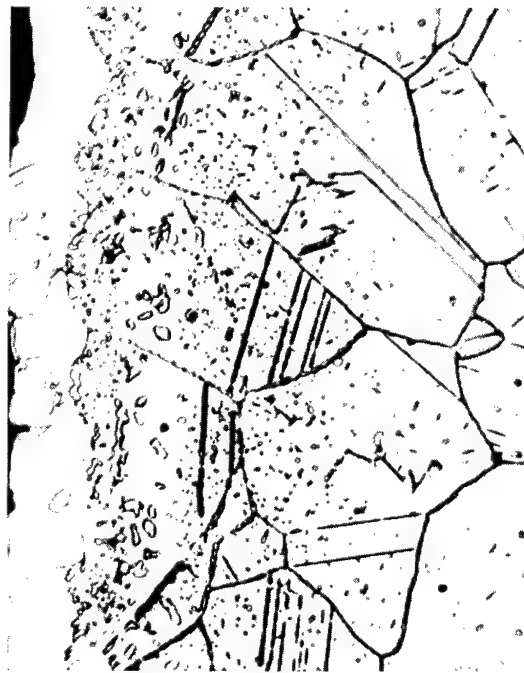
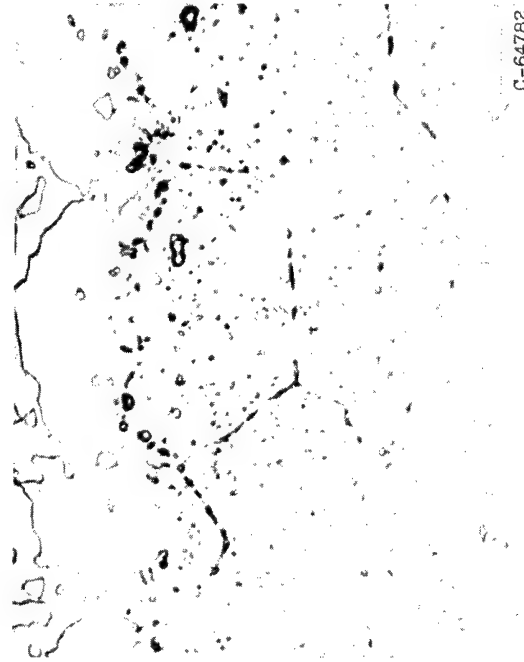
(a) As-received.

(c) NiCrSiB coated at 2075° F for 15 minutes.

(b) Braze-temperature-cycled at 2075° F for 15 minutes.

(d) NiCrSi coated at 2075° F for 15 minutes.

Figure 10. - Microstructures of L-605 stress-rupture specimens prior to testing. Electrolytically etched in a solution of 70 parts saturated boric acid solution, 30 parts 5 percent sulfuric acid solution. X900.

Comparative photomicrographs of specimens braze-temperature-cycled at these two temperatures are given in figures 10(b) and 13. Even though the specimen in figure 13 had been stress-rupture tested 3.8 hours, no significant metallographic differences were noted.

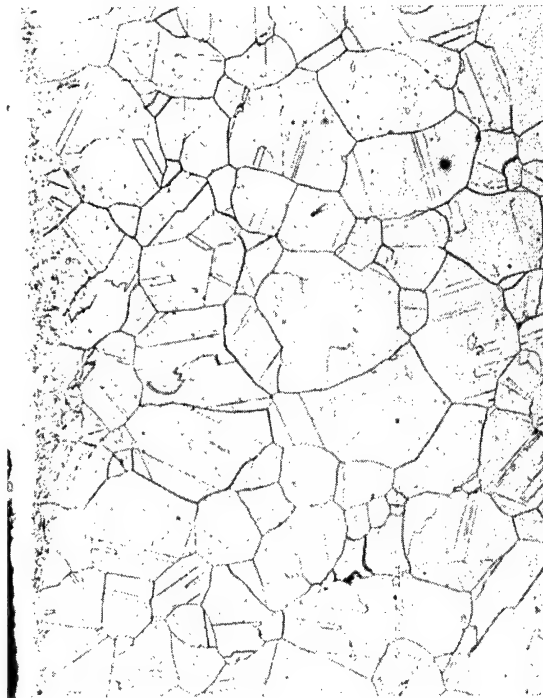
(a) As-received.

(b) Braze-temperature-cycled at 2075° F for 15 minutes.

(c) NiCrSiB coated at 2075° F for 15 minutes.

(d) NiCrSi coated at 2075° F for 15 minutes.

Figure 11. - Microstructures of L-605 stress-rupture specimens prior to testing. Electrolytically etched in a solution of 70 parts saturated boric acid in water, 30 parts 5 percent sulfuric acid solution. X250.

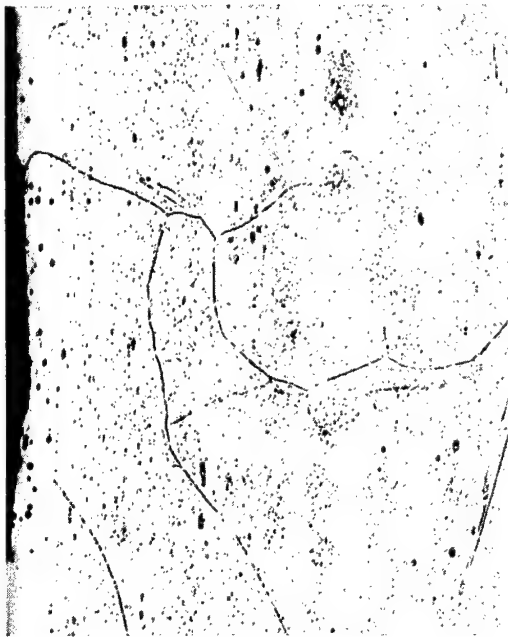
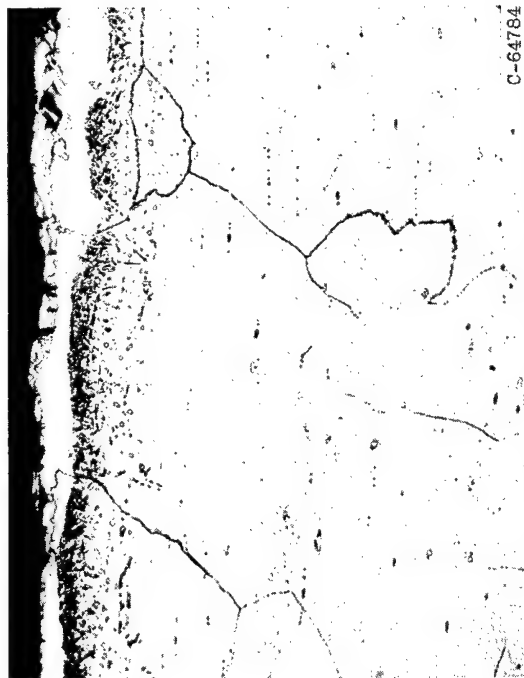
(a) Solution treated; operated 32.8 hours. Etched in glycerine - aqua regia.

(b) Solution treated and braze-temperature-cycled (2075° F) for 15 minutes; operated 3.5 hours. Etched in glycerine - aqua regia.

(c) Solution treated and NiCrSiB coated at 2075° F for 15 minutes. C-64784

Figure 12. - Microstructures of L-605 stress-rupture specimens. Solution treated at 2250° F for 30 minutes. Electrolytically etched in aqua regia in glycerine or solution of 70 parts saturated boric acid solution, 30 parts 5 percent sulfuric acid solution. X250.

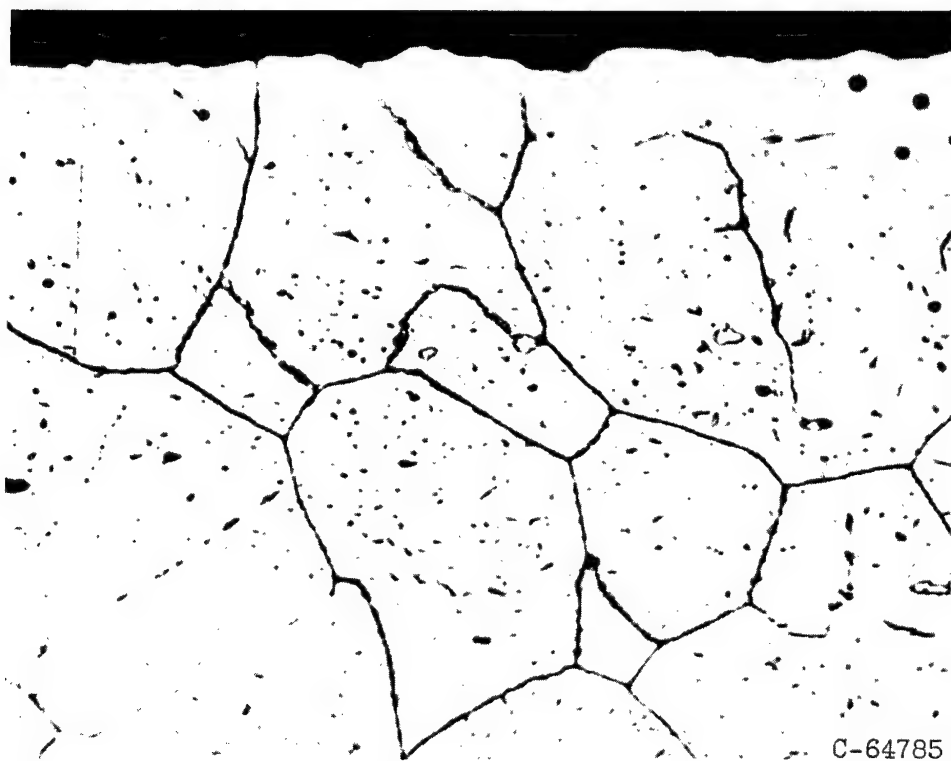
Figure 13. - Microstructure of L-605 stress-rupture specimen braze-temperature-cycled at 2150° F for 15 minutes; operated 3.8 hours. Electrolytically etched in solution of 70 parts saturated boric acid solution and 30 parts 5 percent sulfuric acid solution. X900.

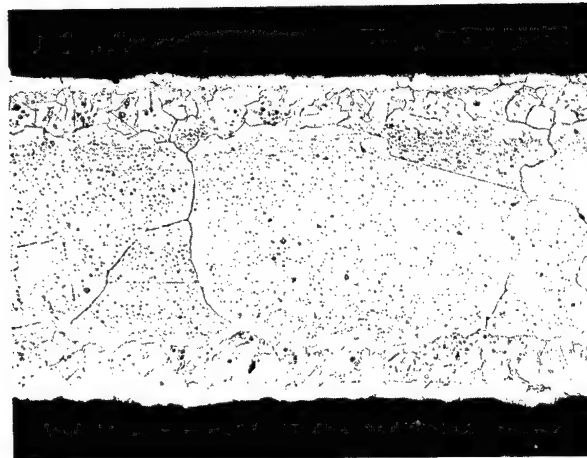
(a) As-received.

(b) Nickel plated.

(c) Nickel plated and braze-temperature-cycled at 2075° F for 15 minutes.

(d) Nickel plated and NiCrSiB coated at 2075° F for 15 minutes.

(e) Nickel plated and NiCrSi coated at 2075° F for 15 minutes.

Figure 16. - Microstructures of A-286 stress-rupture specimens prior to testing. Electrolytically etched in a solution of 50 percent distilled water, 40 percent hydrochloric acid, and 10 percent nitric acid. X100.

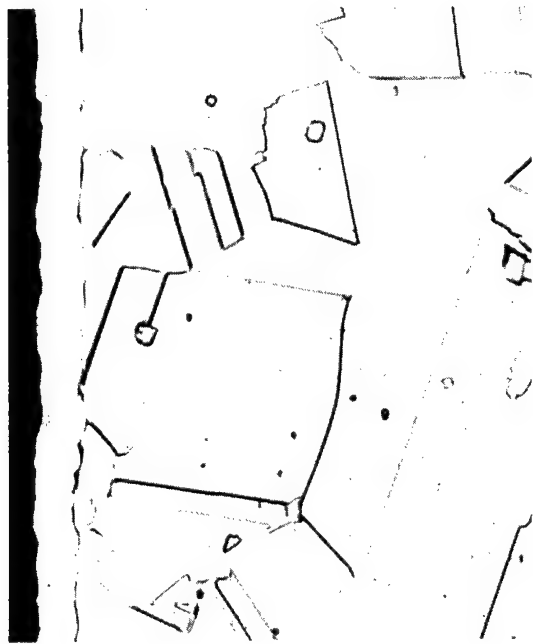
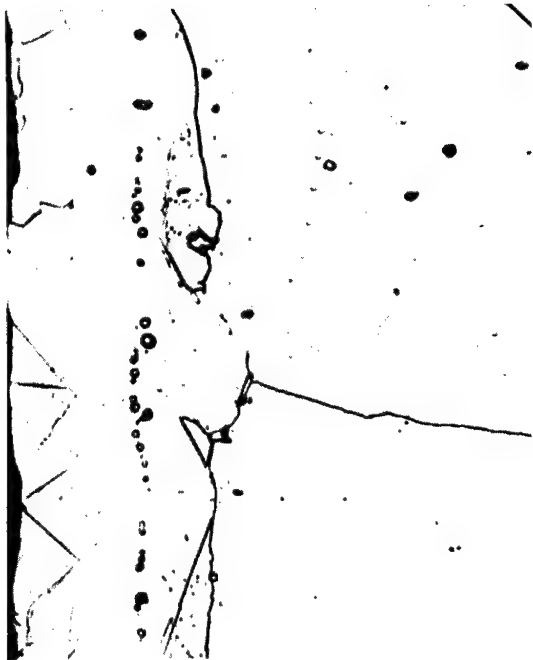
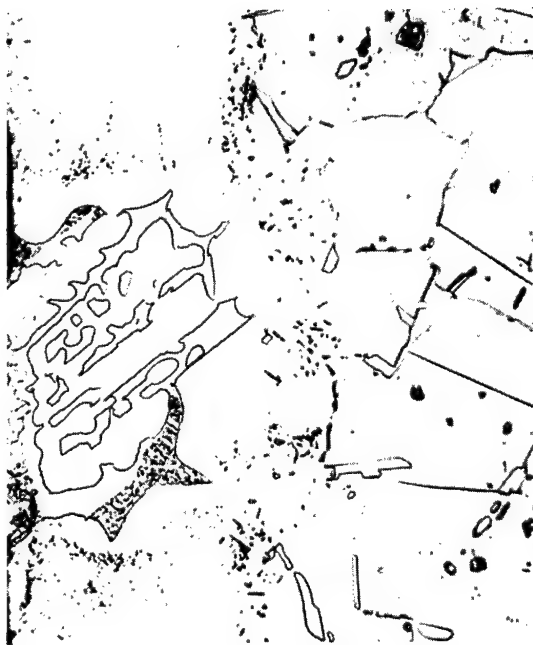
(a) Nickel plated.

(b) Nickel plated and braze-temperature-cycled at 2075° F for 15 minutes.

(c) Nickel plated and NiCrSiB coated at 2075° F for 15 minutes.

(d) Nickel plated and NiCrSi coated at 2075° F for 15 minutes.

Figure 17. - Microstructures of A-286 stress-rupture specimens prior to testing. Electrolytically etched in a solution of 50 percent distilled water, 40 percent hydrochloric acid, and 10 percent nitric acid. X900.

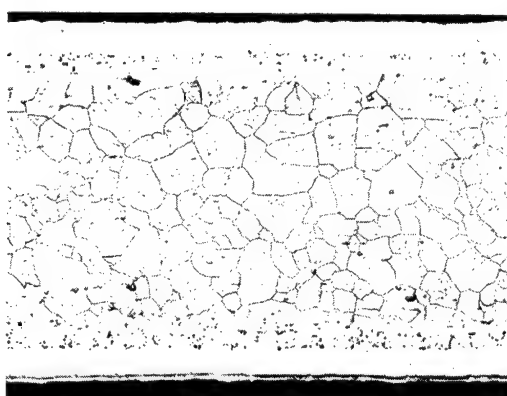
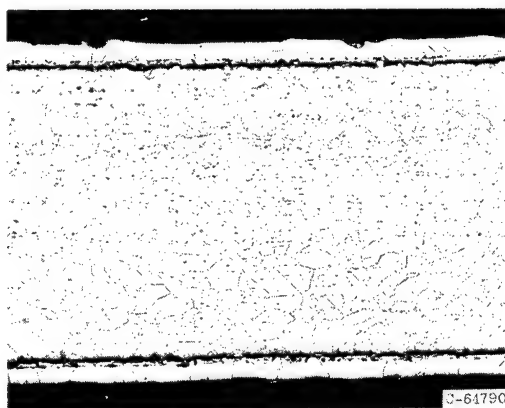
(a) As-received.

(b) Braze-temperature-cycled at 2075° F for 15 minutes.

(c) Nickel plated.

(d) Nickel plated and braze-temperature-cycled at 2075° F for 15 minutes.

(e) Nickel plated NiCrSiB coated at 2075° F for 15 minutes.

(f) Nickel plated and NiCrSi coated at 2075° F for 15 minutes. Etched in 92 parts hydrochloric acid, 5 parts sulfuric acid, 3 parts nitric acid.

Figure 18. - Microstructures of Inconel 700 stress-rupture specimens prior to testing. Electrolytically etched in a solution of 50 percent distilled water, 40 percent hydrochloric acid, and 10 percent nitric acid unless otherwise noted. $\times 100$. Photographs reduced 39 percent.

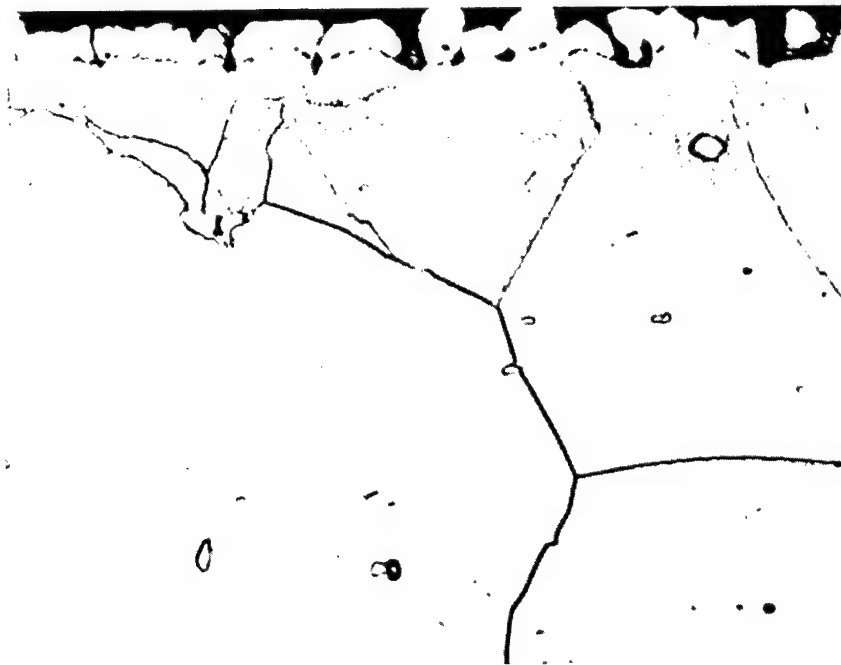
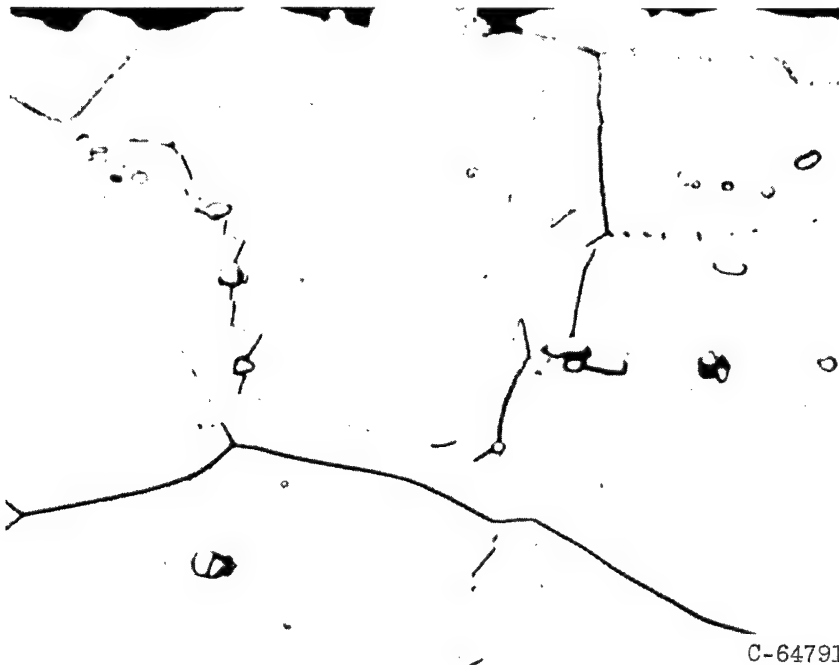
(a) As-received.

(b) Braze-temperature-cycled at 2075° F for 15 minutes.

Figure 19. - Microstructures of Inconel 700 stress-rupture specimens prior to testing. Electrolytically etched in a solution of 20 parts glycerine, 20 parts water, 10 parts nitric acid, 5 parts hydrofluoric acid. $\times 900$. Photographs reduced 23 percent.
